## What are the common problem for Interior Walls ?

# One-Stop Anti-Patchiness Internal System:

## Compatible Interior System Solution from Bare to Finish

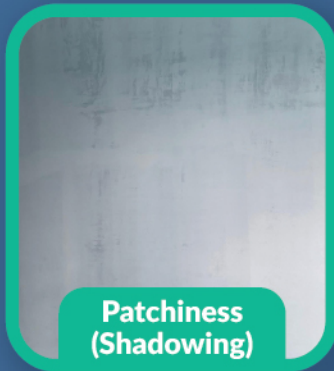
**Patchiness  
(Shadowing)**

Different absorption rates of paint on skim coat leads to various interior wall defects.

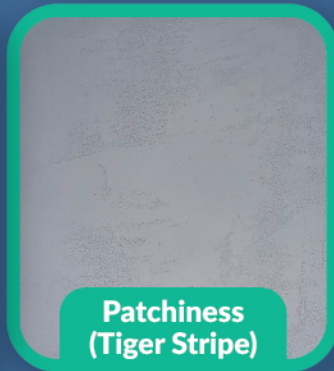
**Patchiness  
(Tiger Stripe)**

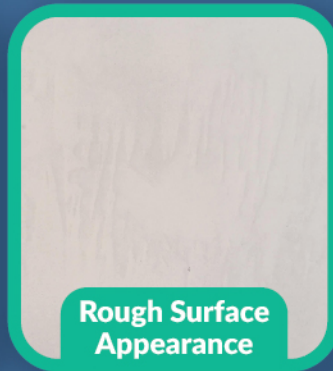
**Rough Surface  
Appearance**

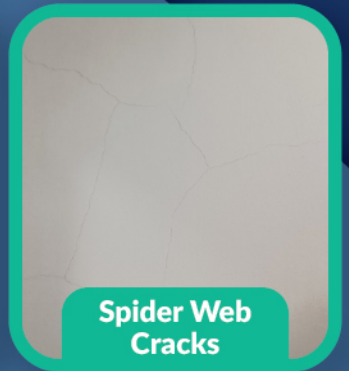
**Spider Web  
Cracks**

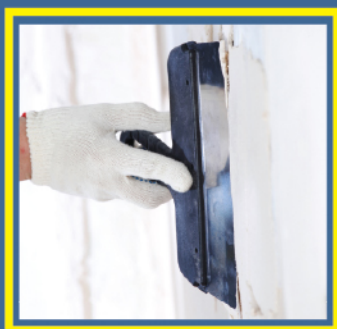
**Overly compressed  
skim coat**

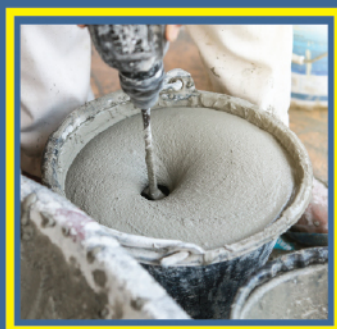
**Improper mixing  
conditions**

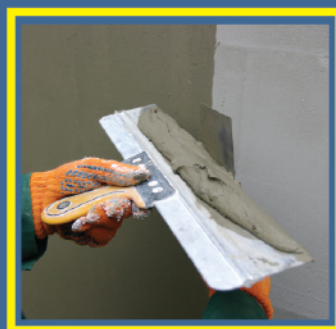
**High moisture content  
on application**

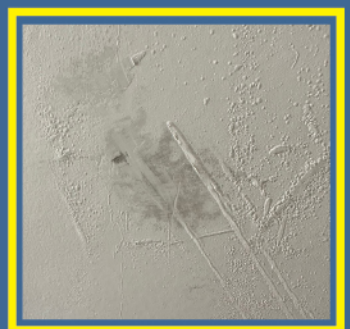
**Incompatible  
skim coat & paint**

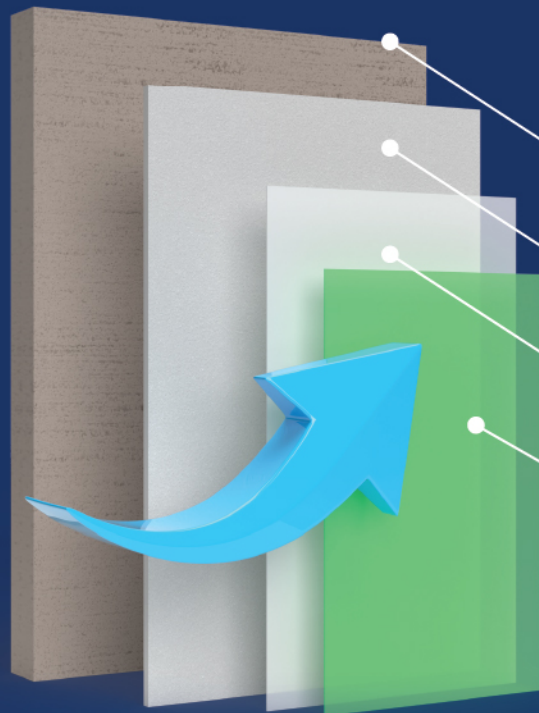
**SKIM COAT (BASE COAT):**  
CMI® Base Mortar 781 Grey  
CMI® BlockSkim 782 (For Block Walls)

**SKIM COAT (TOP COAT):**  
CMI® WallSkim 681 PLUS

**SEALER:**  
Nippon Paint Interior Wall Sealer

**TOPCOAT:**  
Nippon Paint Interior Topcoat
